Radon Mitigation for the CUORE Installation

on behalf of *The CUORE Collaboration*

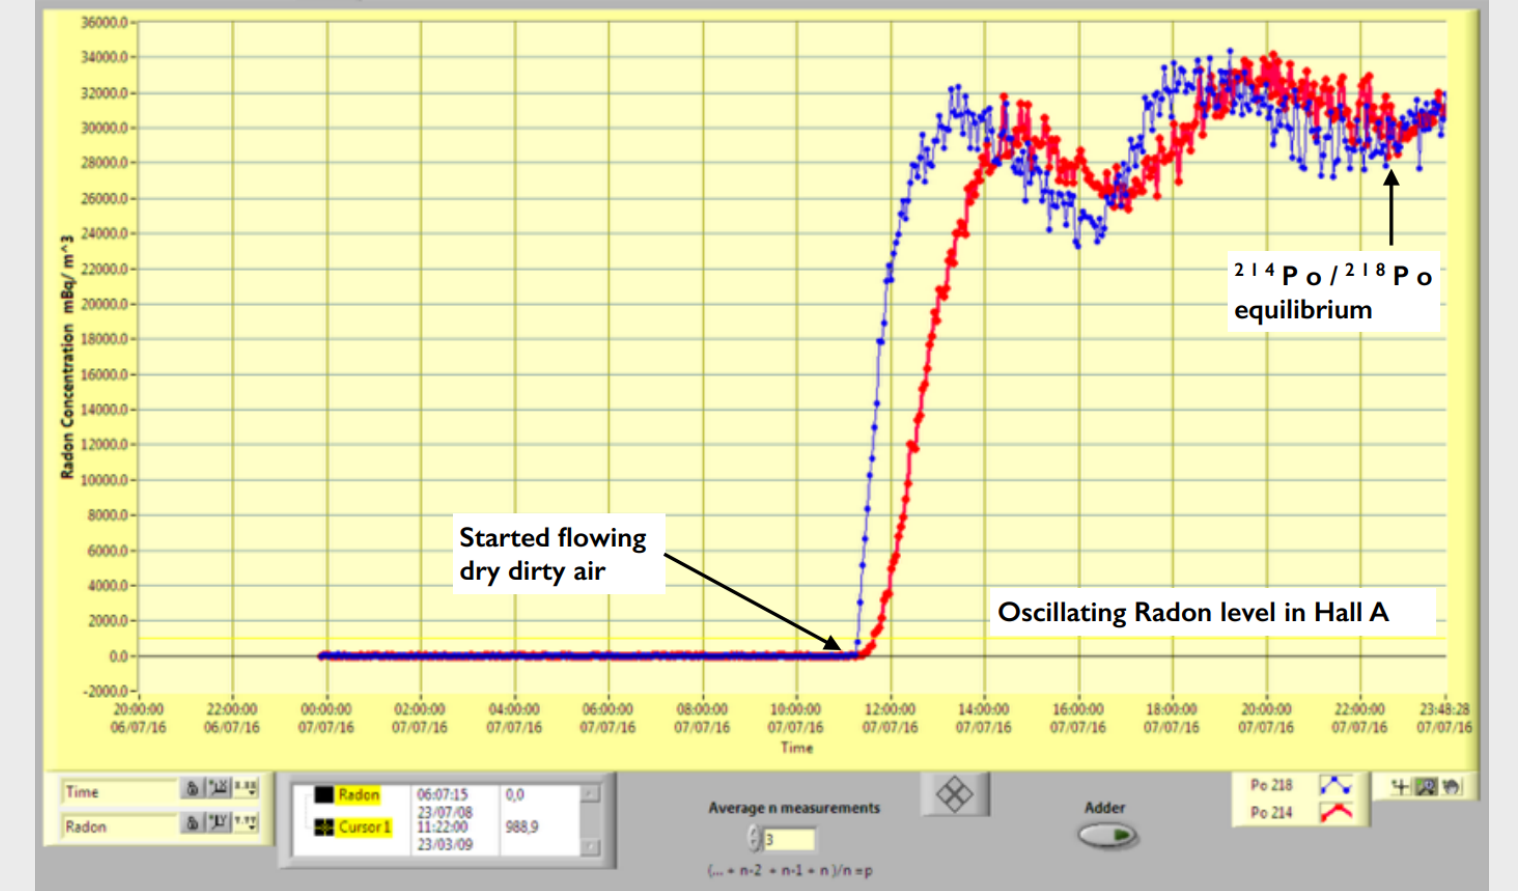
- ▶ Prior to the installation of the detector towers in CUORE, a characterization of the radon abatement system and of the radon monitor was performed. After flushing CR6 with radon-free air for two days and pumping air from it into the radon monitor, the air with $<5\%$ relative humidity exiting the dryer was measured for about one day. Within a couple of hours the ²¹⁸Po content went up to 30 Bq/m³. About 6 hours later ²¹⁸Po and ²¹⁴Pb were in equilibrium. This measurement indicated that the efficiencies, previously measured by the radon monitor developer, were reliable and could be exploited for the measurement of CR6 air.

- ▶ Successively, the air from CR6 was measured after it had been flushed from the radon abatement system for several days. The radon level went down to ~ 10 mBq/m³ within about 7 hours, which corresponds to the recovery time of the entire system after a possible failure.

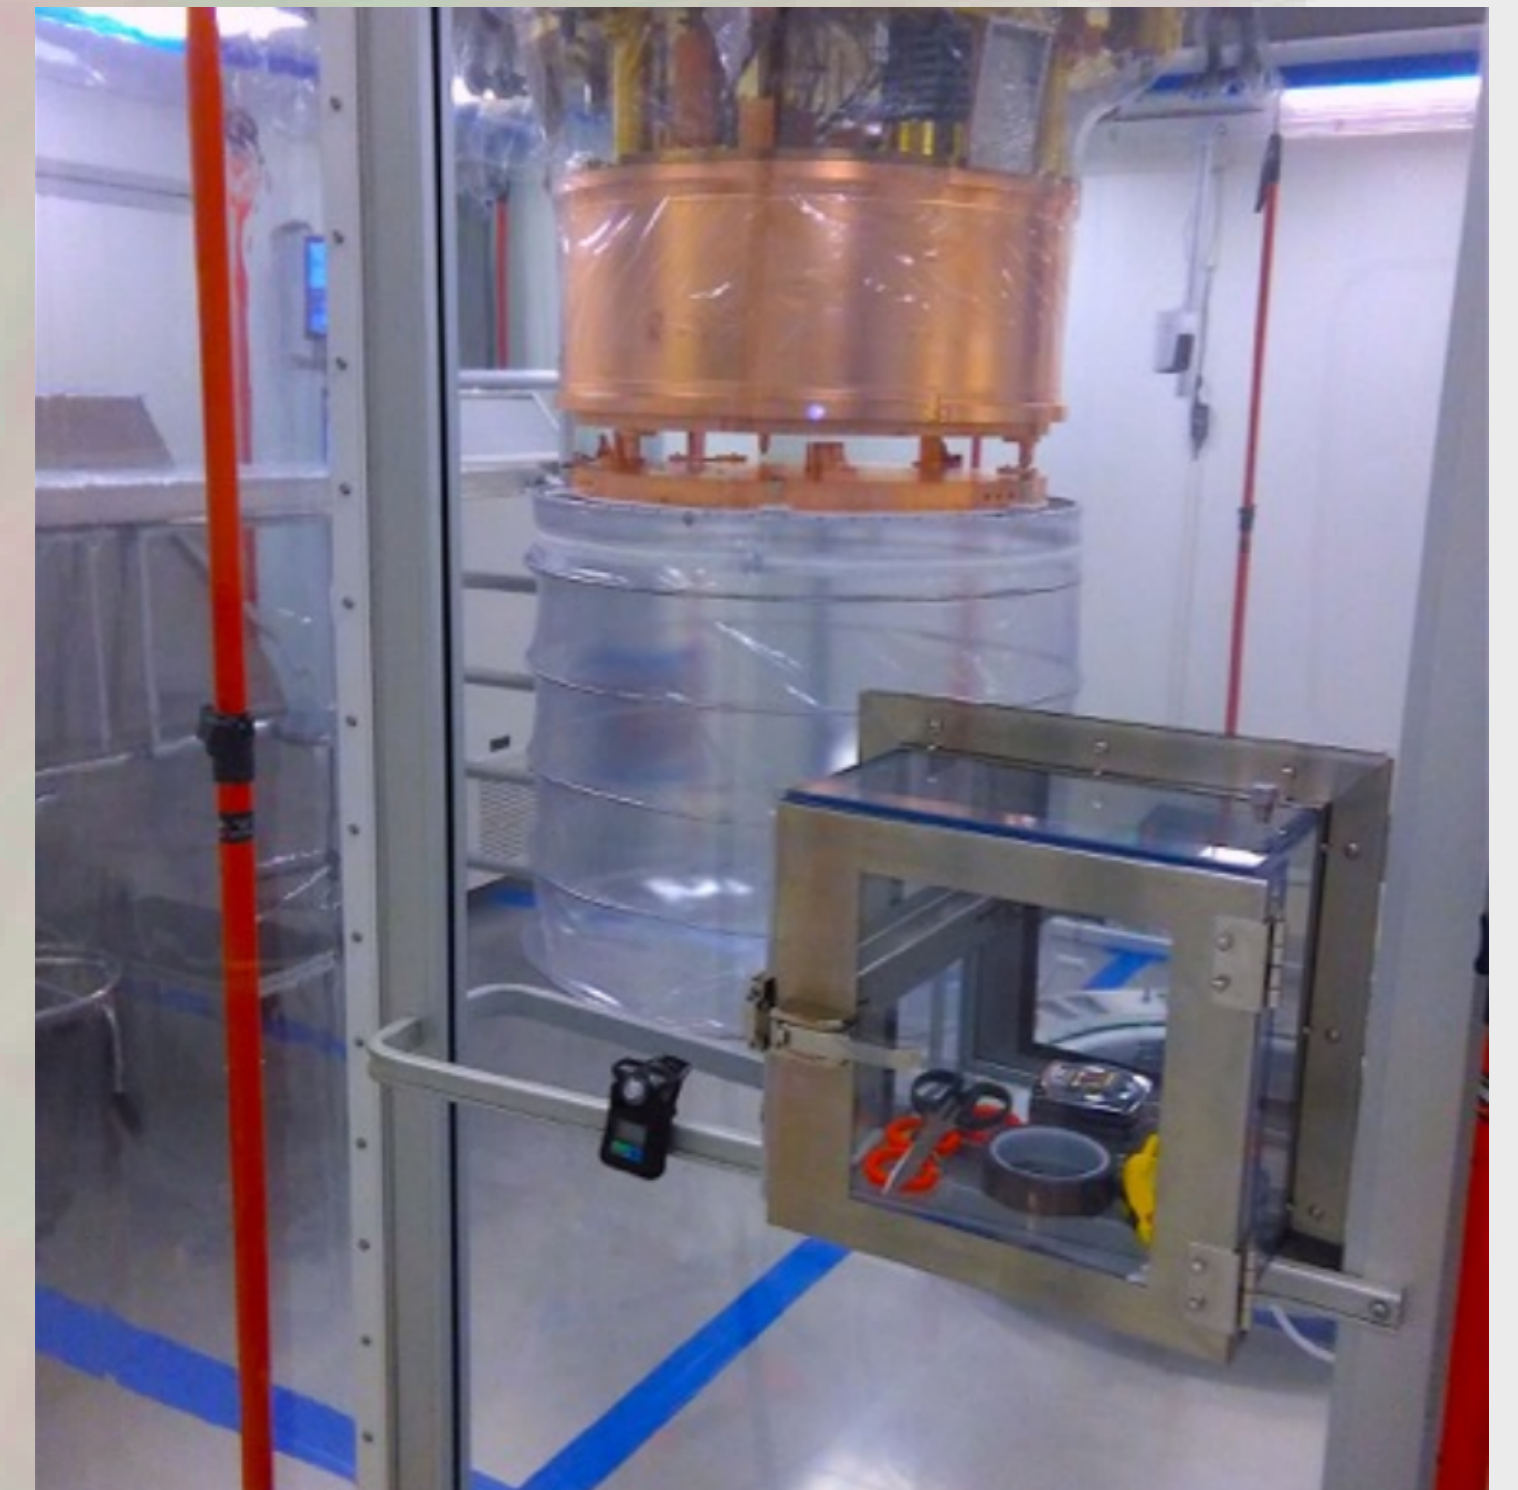
- ▶ The entrance of CR6 consisted of a vestibule whose aim was to further separate the radon-free environment dedicated to the detector handling from the rest of the world. A set of tests were performed before the start of the towers installation in order to determine the safe procedures for the access of CR6. The most important measure regarded the minimum time necessary between the entrance in the vestibule and the transfer to CR6 in order not to induce a radon-level increase up to more than a safe threshold, defined as 100 mBq/m³.

- ▶ The response time of the radon monitor was measured with the simultaneous opening of the vestibule and CR6 doors, resulting in 7 min. With a waiting time in the vestibule of ≥ 10 min, the radon level was staying below the required level.
